PROPERTY CONDITION ASSESSMENT
OF
WORLD TRADE CENTER PORTFOLIO

SUBGRADE

NEW YORK, NEW YORK

Re: Due Diligence Physical Condition Survey
World Trade Center
New York, New York

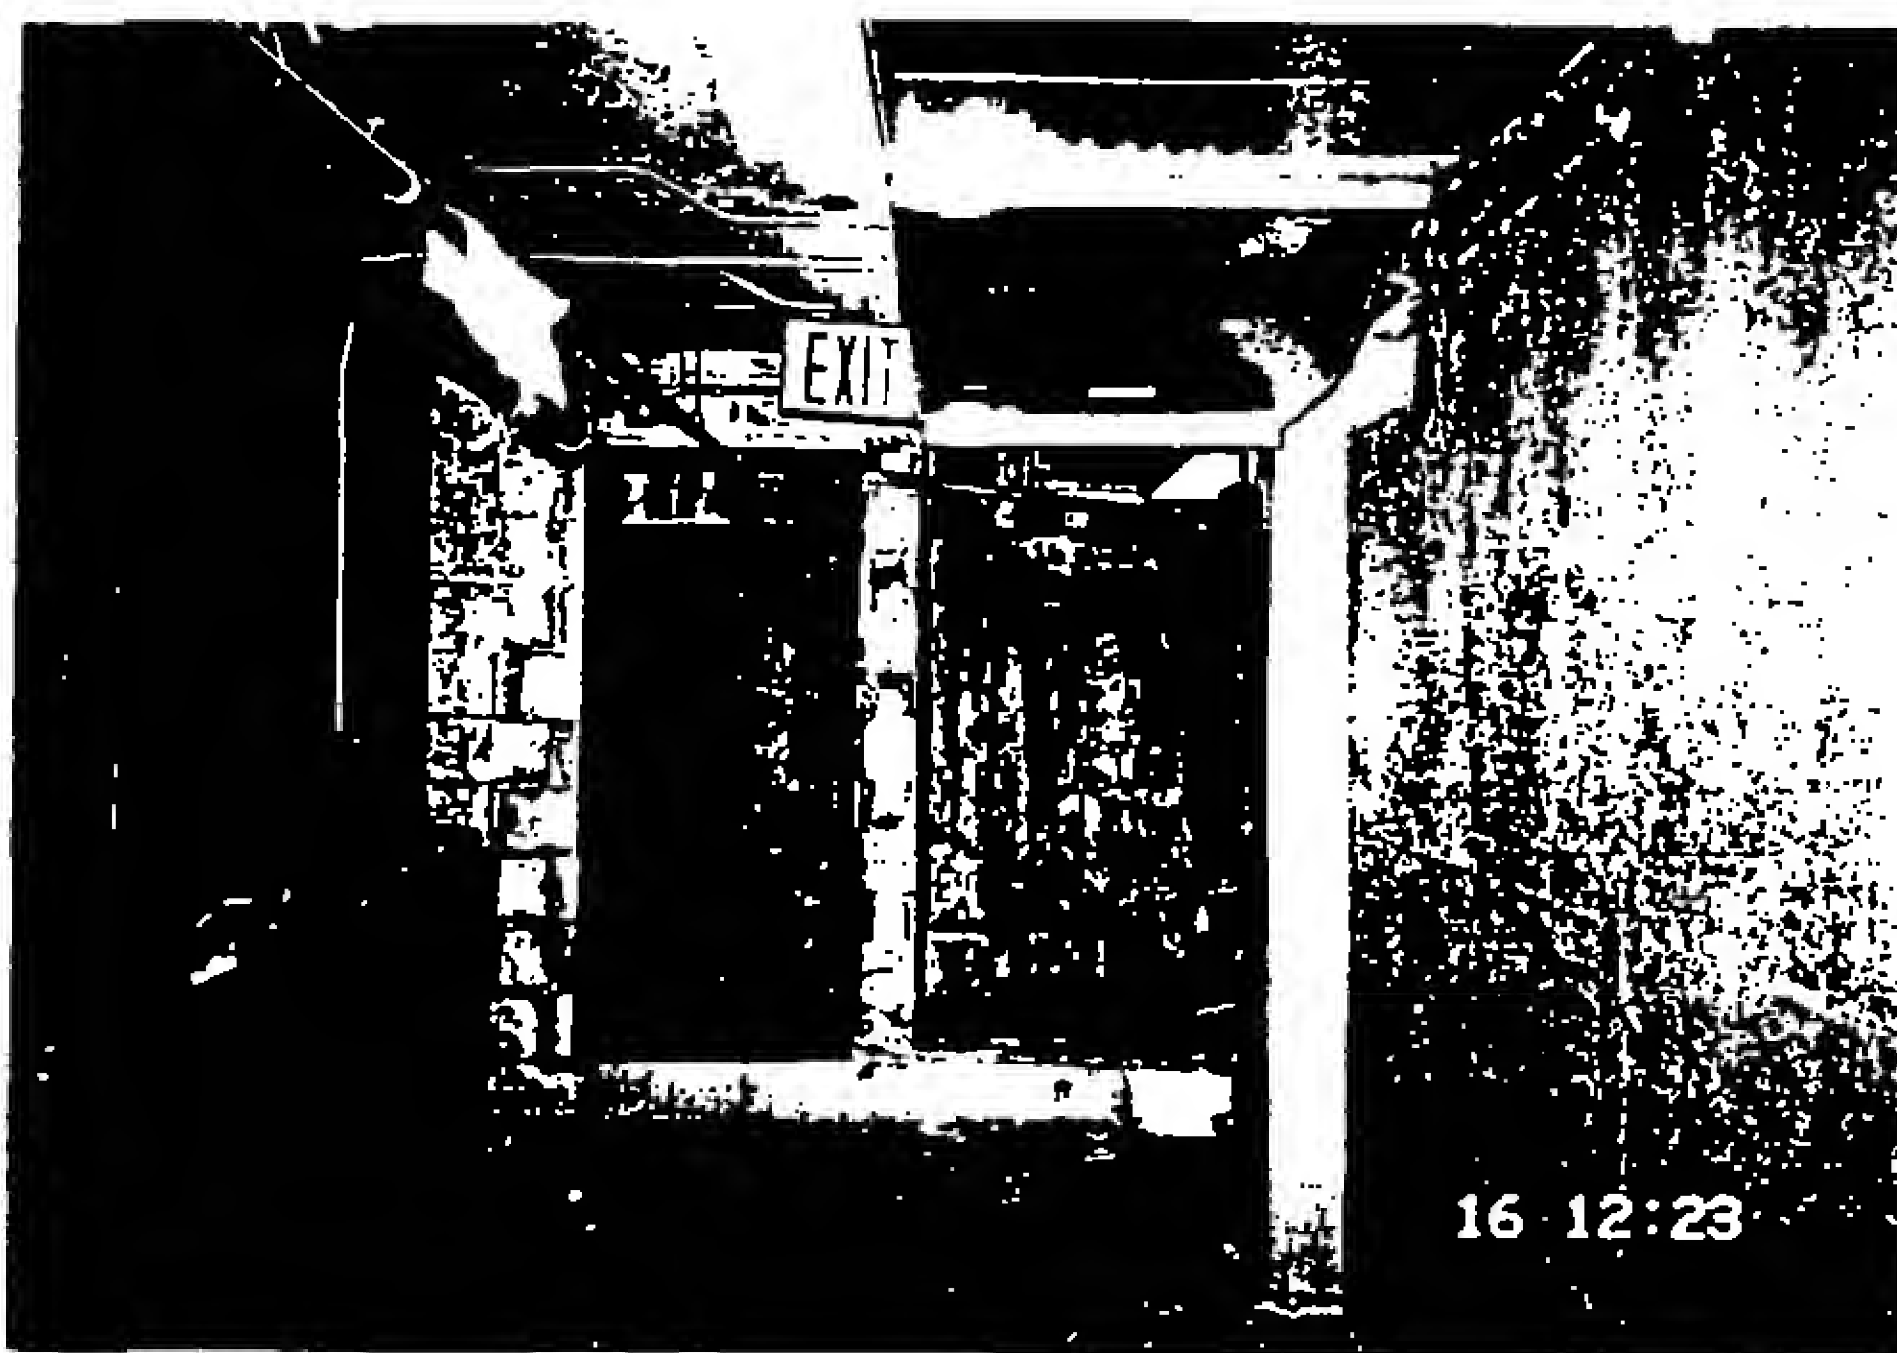
Photograph 24

B4 northeast stair
door being replaced
